Cargo Compartment Fire Protection in Large Commercial Transport Aircraft

July 1998

DOT/FAA/AR-TN98/32

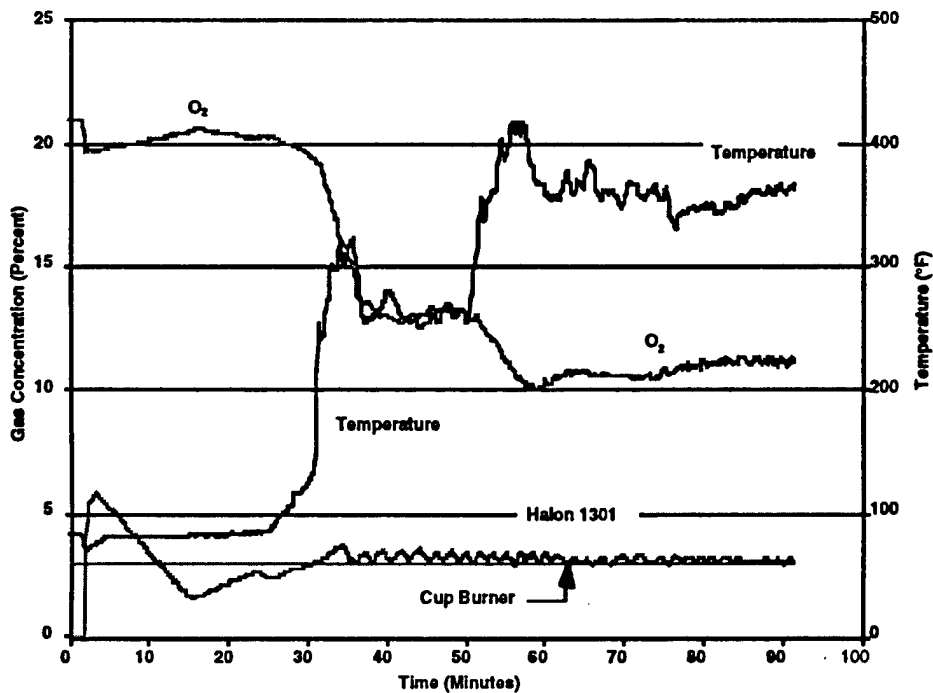
FIGURE 1. GAS AND TEMPERATURE PROFILES IN CARGO COMPARTMENT DURING BULK-LOADED FIRE SUPPRESSION TEST WITH HALON 1301

The results of these 90-minute tests were generally similar to previous shorter duration tests conducted with these agents. [8] The cargo compartment ceiling temperatures ranged from 300 to 450°F while the fires were suppressed and the oxygen concentrations were reduced to 10% to 15%. The depletion of oxygen was caused both by smoldering fires and the displacement of air by suppression agents. Figures 1 and 2 show the ceiling temperatures, oxygen concentrations, and agent concentrations measured in the cargo compartment for the tests with Halon 1301 and HFC-125, respectively. One anomaly was observed during the test with HFC-125. Shortly after the concentration from the initial discharge had decayed down to the cup burner value of 8.8% and the metering system had started, there was an ignition of combustible gases in the smoke layer above the cardboard boxes. The flame front progressed along the entire length of the compartment at the ceiling level. This caused a sharp rise in ceiling temperature and a drop in oxygen concentration. The fire was suppressed for the duration of the test after this event. A similar event had previously been observed in a test using HFC-125 with a containerized fire load. This type of behavior had not been observed with Halon 1301 or other gaseous candidate replacement agents. Further testing is planned in an attempt to understand this anomaly.

Of particular interest for these longer duration tests was the generation and accumulation of agent decomposition products in both the cargo compartment and in the normally occupied passenger cabin area above it. Figure 3 shows the hydrogen fluoride (HF) concentrations in the cargo compartment for the two tests. The values in the graph are the average concentrations of HF over each 10-minute interval. The higher concentrations of HF between 20 and 40 minutes with HFC-125 are due mainly to the open flame that was present when the combustible gases along the ceiling ignited. This open flame produced significantly more decomposition products than the smoldering suppressed fire. Previous testing showed higher concentrations of HF even where there was no ignition of combustible gases when HFC-125 was used as the suppression agent rather than Halon 1301. This result is expected because not only does HFC-125 contain more fluorine per molecule than Halon 1301, but higher concentrations of HFC-125 are also

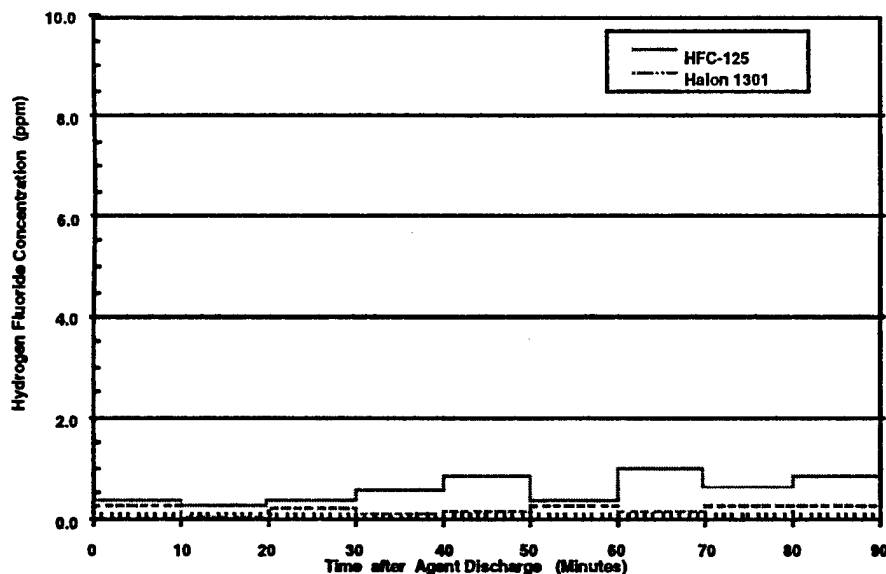
FIGURE 4. HYDROGEN FLUORIDE PROFILES IN PASSENGER CABIN DURING BULK-LOADED FIRE SUPPRESSION TESTS WITH HALON 1301 AND HFC-125

required compared to Halon 1301. Figure 4 shows the HF concentrations in the passenger cabin above the cargo compartment. HF concentrations are again higher in the test with HFC-125 for the same reasons as stated above. However, the data show that there is not a significant accumulation of HF in the cabin area. The fuselage ventilation system exhausts the decomposition products out of the cabin at a rate similar to the inflow rate of these products. The measured levels for both tests were well below the maximum Occupational Safety and Health Administration (OSHA) 15-minute exposure limit of 6 parts per million (ppm) and the Immediately Dangerous to Life and Health (IDLH) limit of 30 ppm.

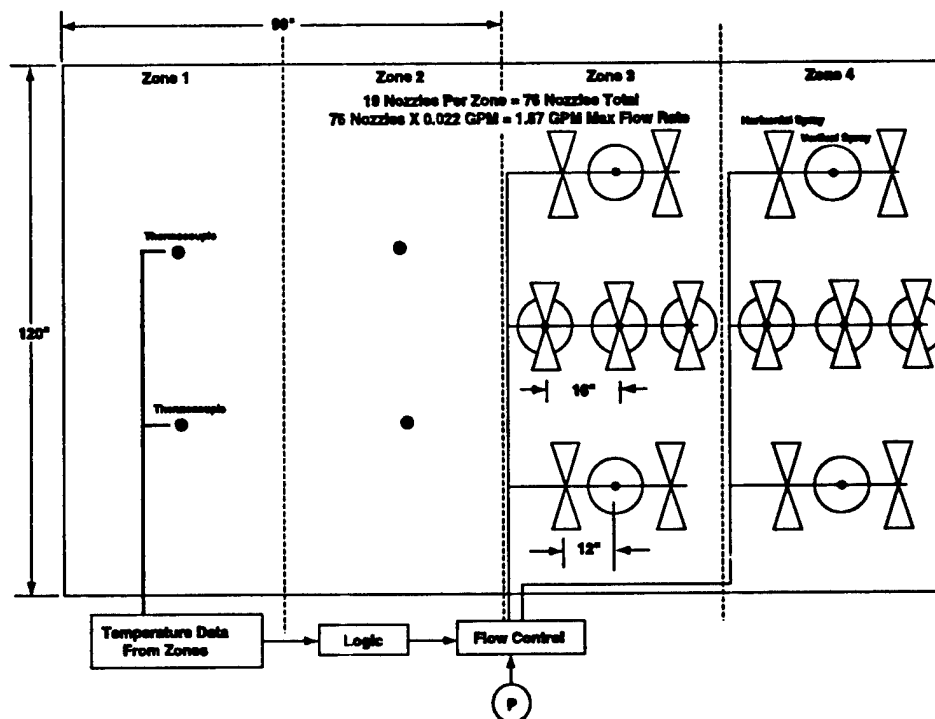
FIGURE 5. WATER MIST SYSTEM SCHEMATIC

A B727 aft cargo compartment test article was used to evaluate a high-pressure water mist system. The test article measured approximately 120 inches wide by 200 inches long at the ceiling (the floor of the compartment covered significantly less area due to the curvature of the fuselage). The compartment volume was approximately 550 cubic feet. The ceiling and sidewall were constructed of the original fiberglass cargo liners; the forward and aft bulkheads were made of aluminum. Two thermocouples were installed along the compartment centerline with three probes each located at 1-, 2-, and 3-foot levels. Video and photographic equipment were placed in the aft bulkhead to monitor test progress.

The water mist system was supplied by Environmental Engineering Concepts (EEC). These systems are commercially available under the trade names Microcool® and Enviromist® Fog Systems and are primarily used for environmental cooling and vegetable hothouse humidification. The system used for the cargo compartment testing was co-designed by the FAA and EEC and consisted of a high-pressure pump, four zone control valves, and the basic piping and nozzles. The water mist system, designed to minimize the amount of waste water by applying the mist to the areas of the fire, was divided into four zones that could be individually activated (see figure 5). Each zone contained 19 nozzles and covered an area of approximately 4 by 10 feet. The nozzles were oriented to spray mist both horizontally and vertically (down) to maximize mixing and coverage. The mist was automatically controlled by two thermocouples mounted in the ceiling of each zone. The control of the spray activation could be adjusted prior to each test. During the test, when either of the zone thermocouples exceeded the preset value, a signal was sent to open the zone control valve, discharging the mist in that zone. The water mist pressure was adjustable from 800 to 1200 psi, as supplied by an electrically driven pump.

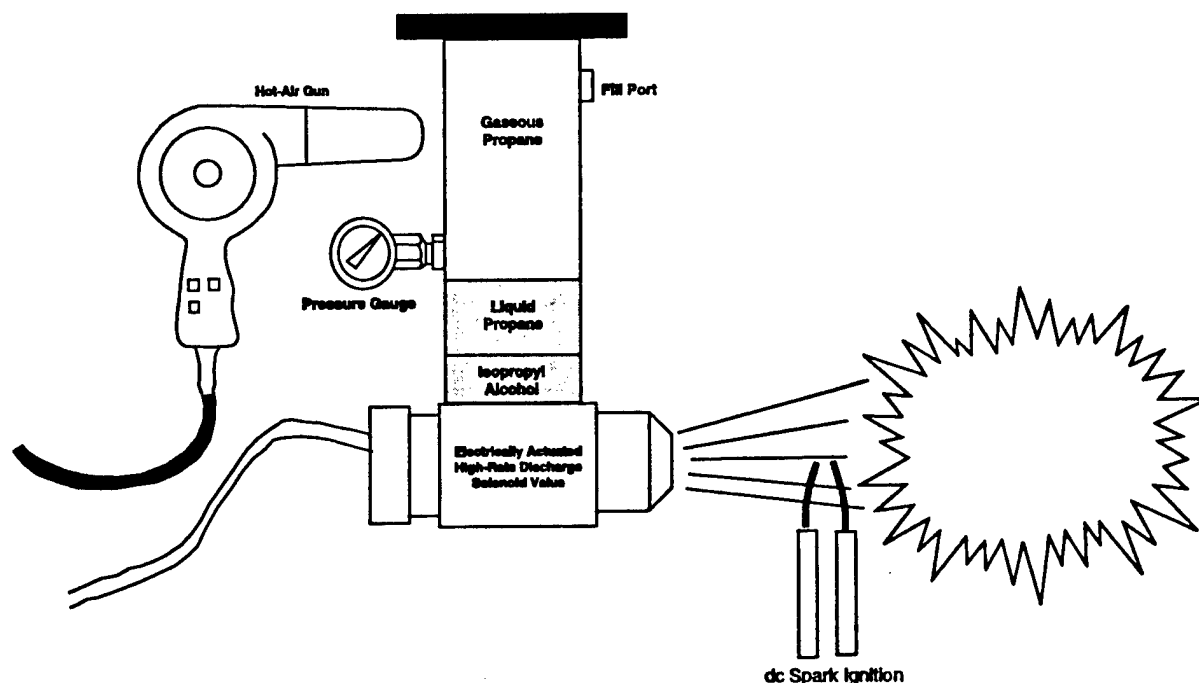
FIGURE 6. EXPLODING AEROSOL CAN SIMULATOR

The initial simulator design was a steel pipe pressure vessel mated to a high-rate discharge (HRD) electrically actuated solenoid valve (see figure 6). The vessel contained ports and valves to transfer the base product (initially isopropyl alcohol) and hydrocarbon propellant (typically propane). The contents are heated by blowing a hot-air gun against the surface of the steel vessel, effectively raising the pressure of the contents. When the pressure was sufficient to burst a standard strength can, approximately 210 psig, the contents were released over a set of direct current (dc) spark igniters. A high-voltage transformer produced the electric spark to bridge the 1.2-cm gap between the pair of electrodes.

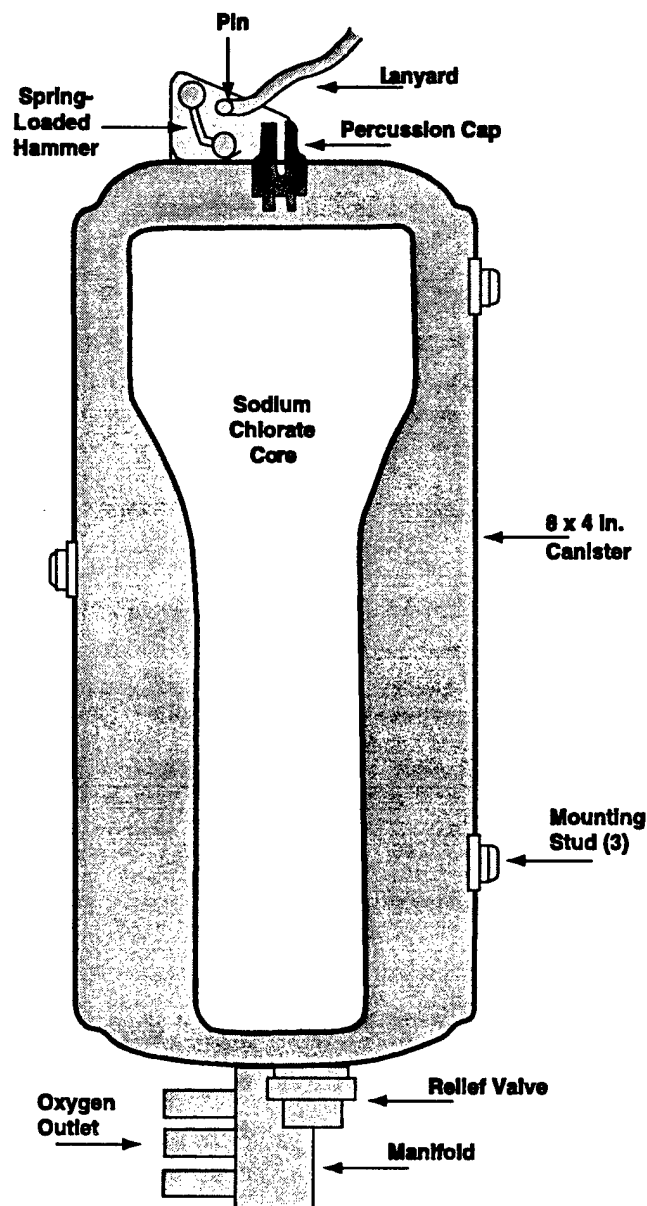
FIGURE 7. CHEMICAL OXYGEN GENERATOR

Most commercial transport aircraft use oxygen canisters to supplement or replace cabin air for passenger breathing in the event of a cabin depressurization. Figure 7 shows the design of a common oxygen canister. The main components are the chemical core composed of sodium chlorate and iron particles, a stainless steel housing, a means of initiating the chemical reaction (such as a spring-loaded hammer striking a percussion cap), and outlets for the gaseous oxygen generated. Because the oxygen-producing reaction is exothermic, the steel housing is insulated from the chemical core to maintain the temperature of the housing below 500°F. As discussed earlier, the activation of improperly packaged and shipped oxygen canisters in the forward cargo compartment was the probable cause of the fatal ValuJet in-flight fire. [5]

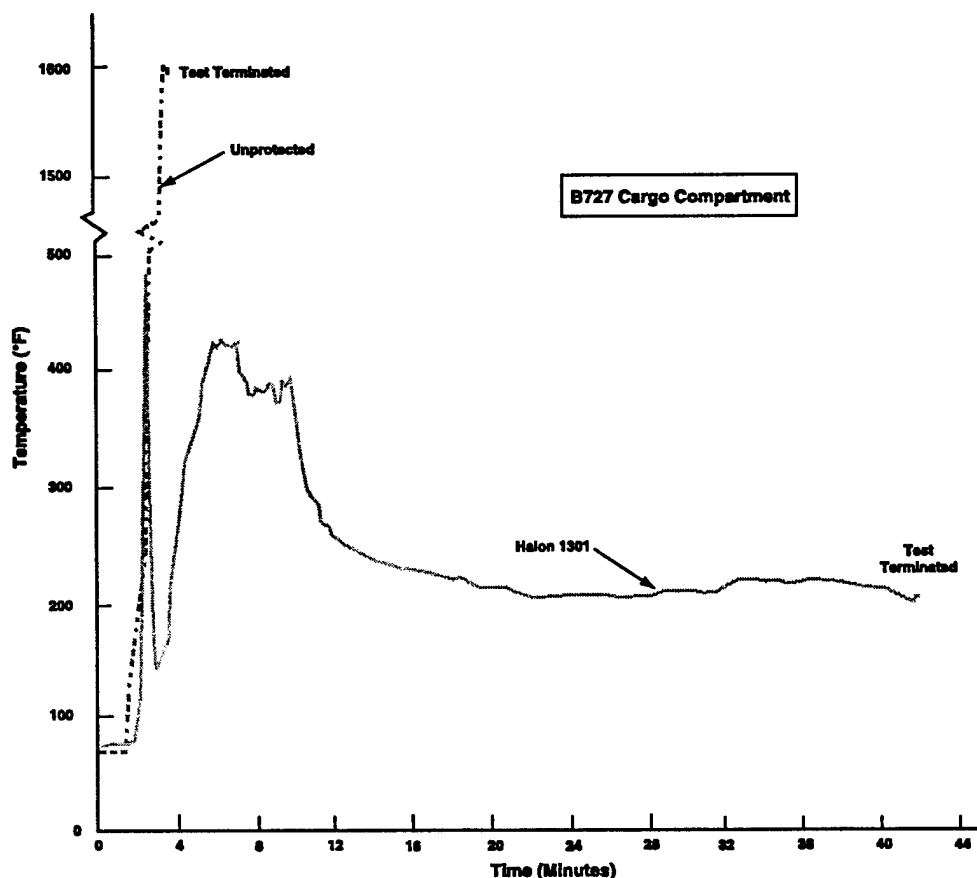
FIGURE 8. COMPARISON OF CEILING TEMPERATURES DURING A CARGO FIRE INVOLVING 12 OXYGEN CANISTERS WITH HALON 1301 SUPPRESSION AND UNPROTECTED

The second test was similar to the first with the following exceptions. Only 12 generators were used; all were stored in one cardboard box. Only a single layer of boxes filled with shredded paper was used. In this test the fire was detected much faster than in the first test (see figure 8). Temperatures at the ceiling never exceeded 500°F. As in the first test, upon discharge of Halon 1301 the visible flaming was immediately extinguished. However, in this test the ceiling temperature was maintained at about 400°F for approximately 10 minutes and decreased to approximately 200°F for the next 30 minutes. After the fire was extinguished, it was discovered that only 2 of the 12 generators had activated.

The third test was a repeat of test two without using any suppression agent. Temperatures at the ceiling rapidly reached the point where the liner would be breached and the test was immediately terminated (see figure 8).

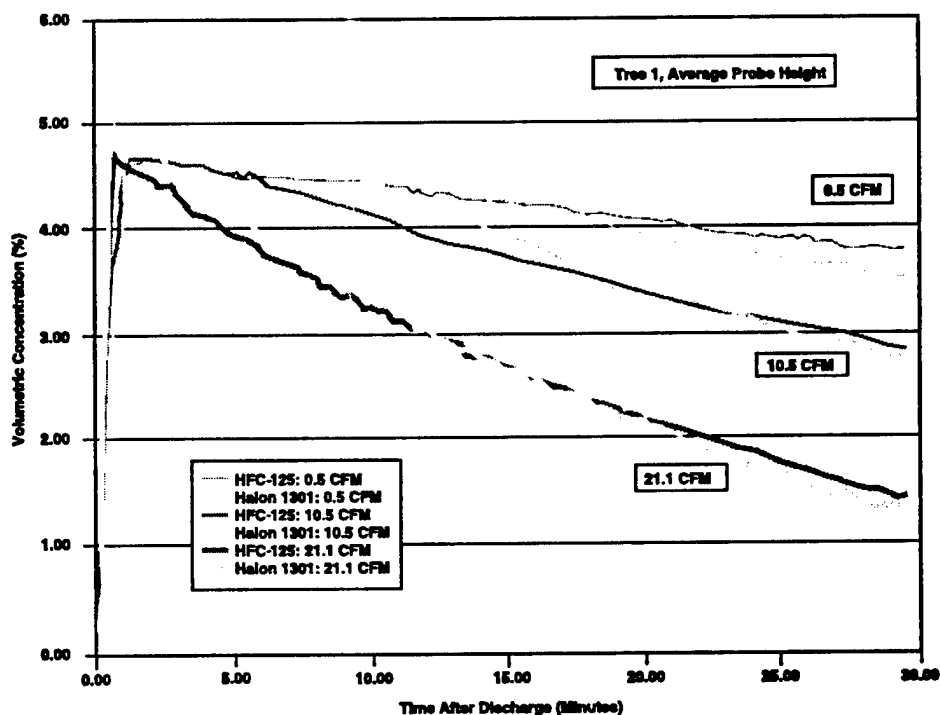
FIGURE 9. AGENT CONCENTRATION HISTORY AT DIFFERENT LEAK RATES

A comparison of the HFC-125 and Halon 1301 concentration histories at the three leakage rates for the sampling tree nearest the leak duct is shown in figure 9. The data represents the average concentration measured at the six sampling heights and from replicate tests at each leakage rate. The higher peak concentrations of Halon 1301 were expected due to the difference in charged weight; 5.8 pounds and 4.45 pounds for Halon 1301 and HFC-125, respectively. Also, the Halon 1301 decays faster than HFC-125 due to its higher vapor density; however, the difference in decay rate lessens as the leakage rate increases. It appears that HFC-125 can be used as a simulant for Halon 1301 provided that suitable conversion equations are used to correlate the concentrations of Halon 1301 and HFC-125.
